Aluminum Wiring by Douglas Hansen

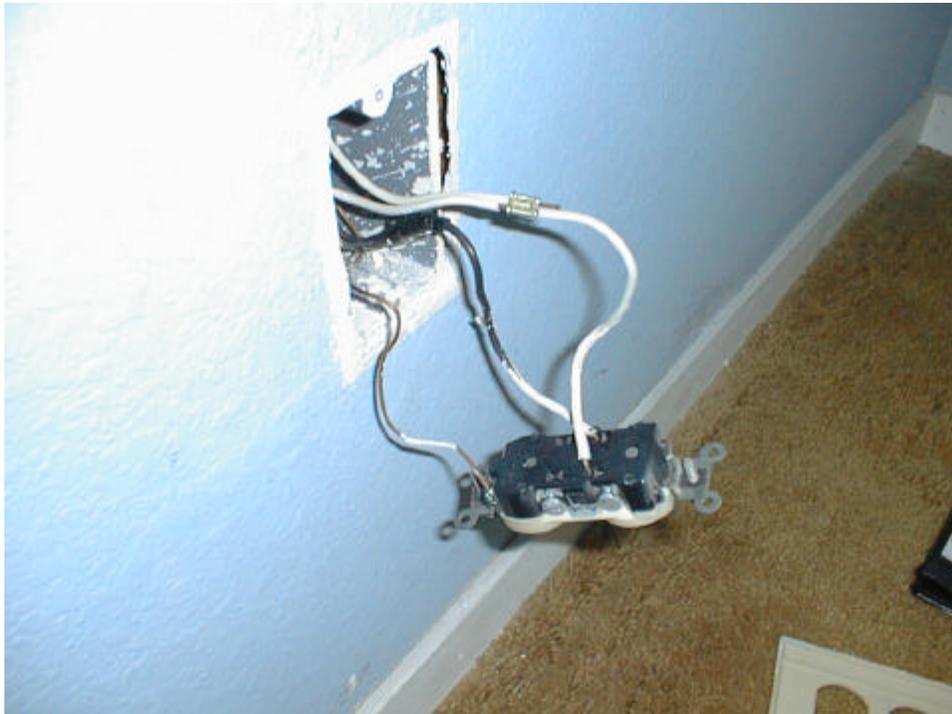
Some of those wiring methods were all right, but a lot of them were suspicious. In the 1960's, it wasn't uncommon to see houses wired with no wire nuts – just twisted splices covered with electrical tape, and to see "barrel crimps" used to connect a second wire to the middle of another wire (figure 1). These connections are weak – very poor by modern standards, and lots of them fail, whether they are copper or aluminum. However, the situation got a lot worse with aluminum when it was shoved into the quick-wire connections at the back of electrical devices.

Figure 1 - Arcing Barrel Crimp Connection with Copper Wire

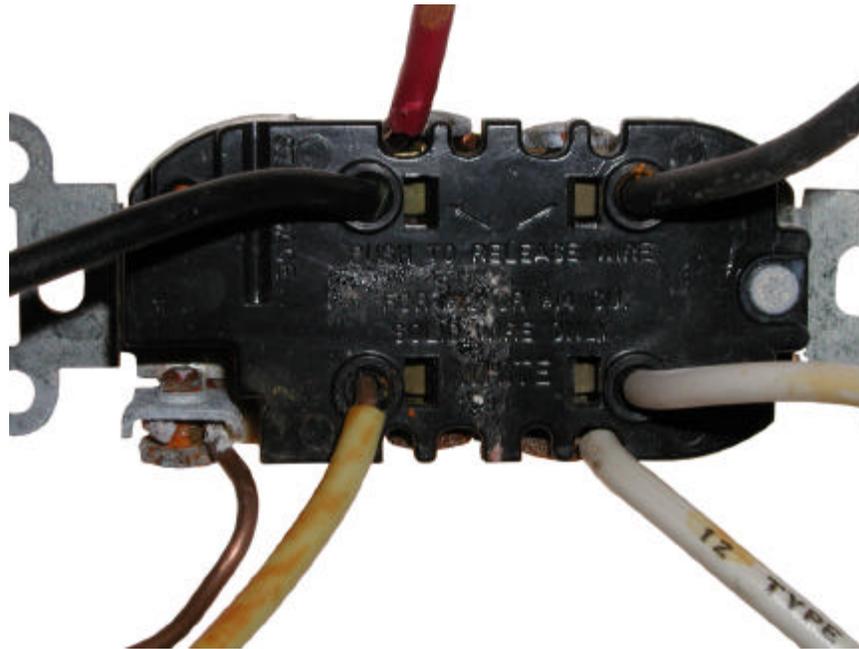
The worst thing done with aluminum in those days was stuffing it into the quick-wire connections at the back of receptacles. A simple way to make connections in a junction box with a receptacle outlet is to feed through it, using the push-in connections in the back (figure 2).

Figure 2 – Old Push-in Connections and Screw Terminal Connections

These push-in connections are bad enough with copper wire. About 10 years ago, UL changed its standards to reduce the size of these holes so that only 14 gauge wire fits into them. That way, they limit these connections to the 15 amp circuits. Of course, since aluminum wire is one size bigger than copper for the same ampacity, that meant that aluminum couldn't be used at all in these push-in connections. Nice idea, though it was 30 years late. Even before the reduction in size of these holes, the device holes were marked as "suitable for solid copper wiring only," but back in the 60's there were no such markings. Electricians just hooked up aluminum wire anywhere it would fit, doing exactly the same things they would do with copper wiring.

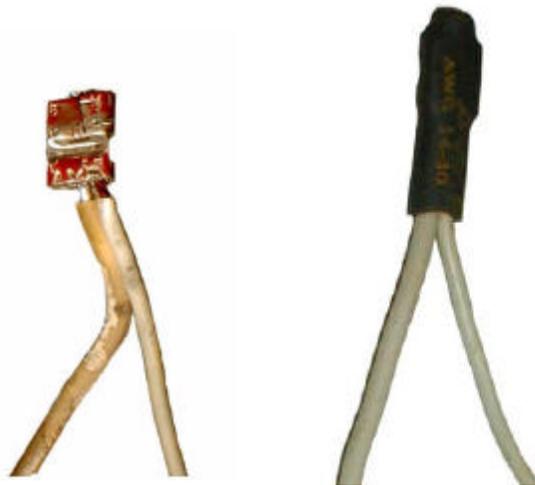
Everyone agreed that aluminum by itself was an adequate conductor, but the problems at the terminations of pre-1972 "old technology" aluminum were causing fires. The aluminum industry was able to point to a solution – the "copalum" connection system from Amp Industries. With this system, a short copper pigtail was placed next to the aluminum, and a crimping die joined the two conductors with a permanent crimp. The resulting connection did not bring the copper and aluminum into direct contact – the die is actually a current-carrying component – and the connection was not plagued by the problems of joining dissimilar metals. The copper pigtail could be safely connected to a switch or receptacle like any other copper wire.

Figure 3 - Copalum Connections

Neither of the methods in figures 5 or 6 is recognized (unless the receptacle in figure 5 is rated CO/ALR) and the CPSC published a brochure regarding Copalum as the only known safe pigtail method. In the 1970's and 1980's, a number of contractors cooperated with the retrofit program by leasing the necessary equipment from Amp Industries. That includes the crimping dies, the tool to perform the crimp, the heat shrink tubing to insulate it, and the heat gun to shrink the tubing. This repair method was once widely available across the United States. The problem with it was that many times the connections could not all be accessed with the tools. Many "repaired" aluminum wire systems are really only partial repairs, and this method could give consumers a false sense of security. The popularity of the system waned in recent years, and today it is difficult to find contractors who can perform a Copalum repair.

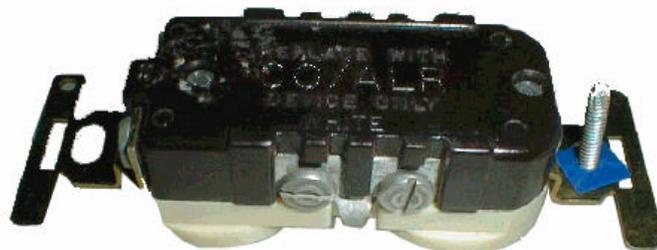
Everyone realized that the problem was at the connections at the wire terminations, so they concentrated on the devices the aluminum connects to. They came up with circuit breakers, switches, and receptacle outlets identified for "Cu/Al" connections. That worked OK with circuit breakers, but the set-screw connections on the receptacles and switches were still failing. Those products were later replaced by "CO/ALR" devices.

Figure 4 – CO/ALR Receptacle

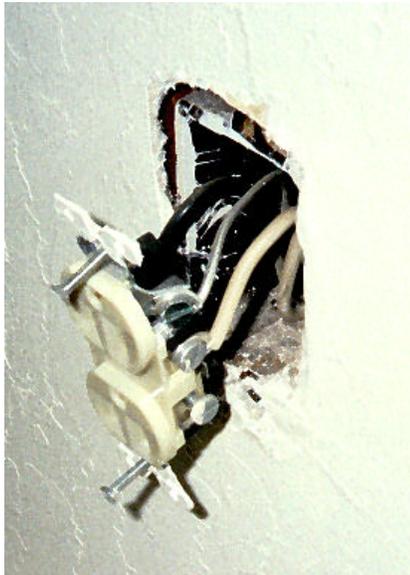
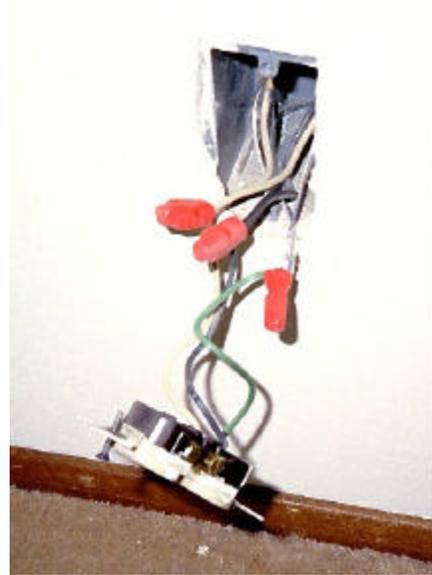
In addition to the CO/ALR receptacles, a number of other methods were attempted in the 1970's. These include connecting aluminum directly to the screw terminals of ordinary receptacles, and the use of copper pigtails with ordinary wire nuts between the copper and the aluminum.

Figures 5 & 6 – Direct Wired Aluminum and Copper Pigtail with Old Style Wire Nuts

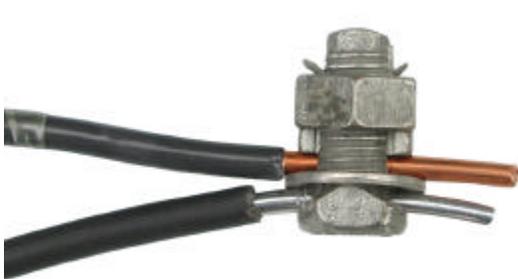
Into this mix we find two other splicing methods that have a UL listing. First was split-bolt connectors (figure 7) , and the next was a wire nut by Ideal that was introduced in February 1995 (figure 8). This wire nut contains an anti-oxidant paste encapsulated inside the connector.

Figure 7 – Split Bolt Connector

Split bolt connectors with a separating plate are very labor intensive, and require a layer of bulking tape and insulating tape. They also can easily crowd an existing box. The Ideal 65 wire nut is basically an ordinary wire nut with anti-oxidant inside it. The wire nut is not approved for aluminum to aluminum connections – one of the conductors in it must be copper. As with all these devices, their effectiveness and safety depends heavily on the quality of the workmanship – there is no “magic bullet” to assure safety in an old technology (pre-1972) wiring system.

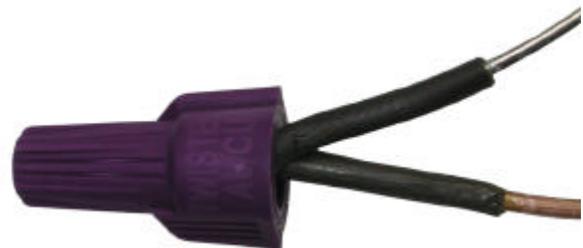
Figure 8 – Ideal 65 Wire Nut
