# Knob & Tube Wiring by Douglas Hansen

**K**nob & Tube wiring was a system of open conductors supported on ceramic knobs. It also used ceramic tubes where wires cross each other or pass through framing. Like most old electrical systems, it is likely to have been damaged or altered over time, and home inspectors often must recommend it be repaired or further evaluated by a qualified electrical contractor.

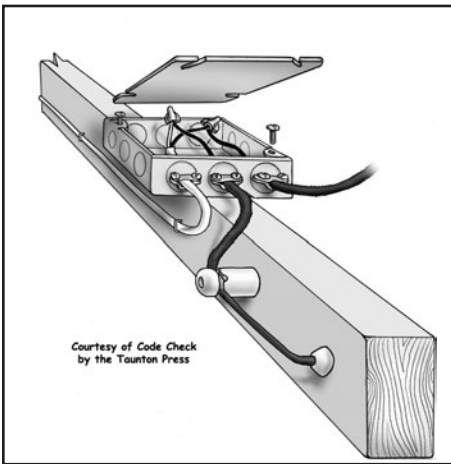
Figure 3 — Proper Splicing Method for Extensions

Splices from knob & tube to another wiring method are often done incorrectly. Even though the original knob & tube splices are exposed, splices to another wiring method must be contained in boxes. Because wires entering a box must

have at least 6 inches of free conductor in the box, a single box is seldom sufficient; two boxes are usually needed.

An A-head device with a bushing is needed at the end of an AC cable before splicing to knob and tube, and loom should cover each con-

ductor of the knob and tube between the last knob and the device. The conductors from the AC cable should only extend as far as necessary to have an open splice into the knob & tube. Due to the lack of availability of older loom, some jurisdictions allow a piece of Romex® sheathing as a substitute for loom. In most instances, splices are improper and should be avoided. New circuits are usually a better choice instead of extending the older wiring system.

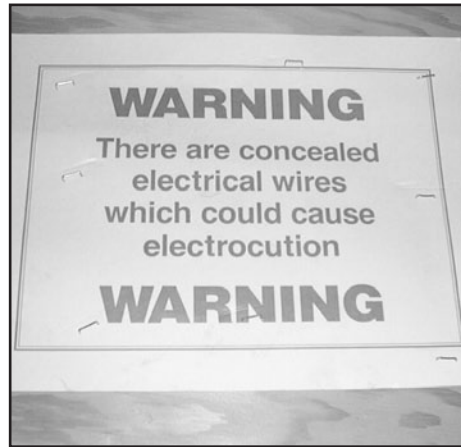
Figure 4 — Warning Sign

3. Accessible areas where insulation has been installed over the wiring must be posted with a warning sign (figure 4). In some jurisdictions, the sign must be in Spanish and English.

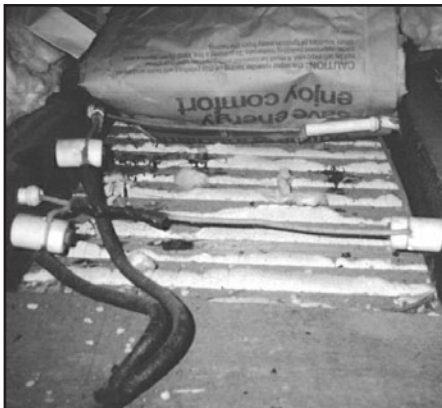
Figure 5 - Paper Faced Insulation

4. The insulation must be non-combustible. Paper-backed fiberglass (figure 5) would not qualify.
5. The insulation must be non-conductive. Foil-faced fiberglass (figure 6) would not qualify.

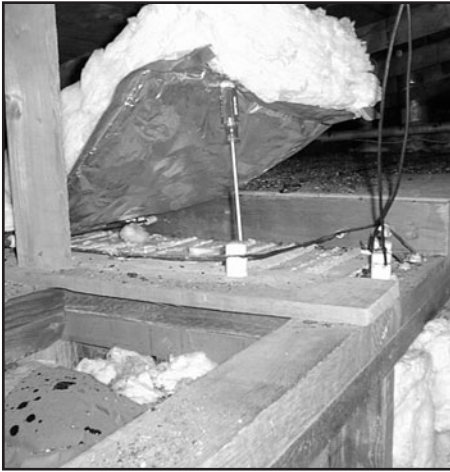
Figure 6 — Foil-Faced Insulation

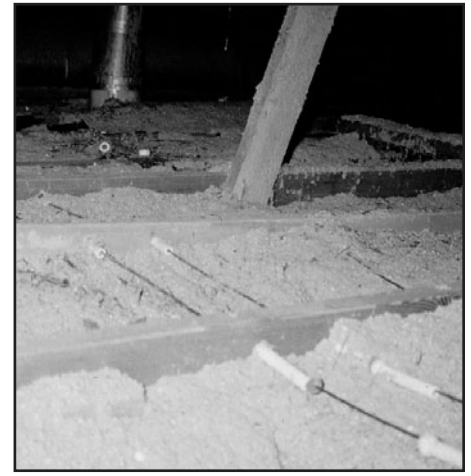
Figure 7 — Non-Flammable Insulation

insulation are treated with materials to inhibit flame spread. Some materials, including loose cellulose, have failed flame-spread tests after they were installed. Cellulose insulation (figure 7) is made of ground-up newsprint and a fireproofing chemical (usually a borate) mixed dry. It is possible the chemicals settle out of the insulation, reducing its fire resistance. Loose fiberglass does not have the same concerns regarding flammability.
